Manhole Inspection Summary

Manhole # S29YY_018MH

Location Address: **3252 33RD ST**

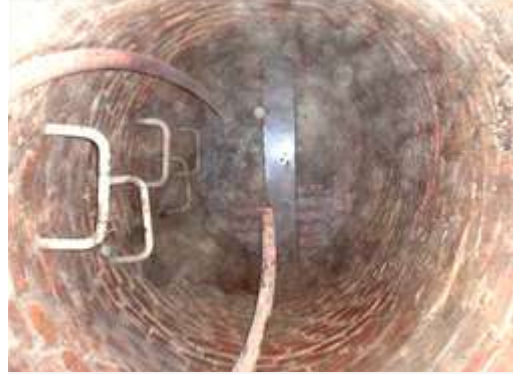
Top View

Corroded steps. Evidence of surcharge - Bench debris. Channel debris.

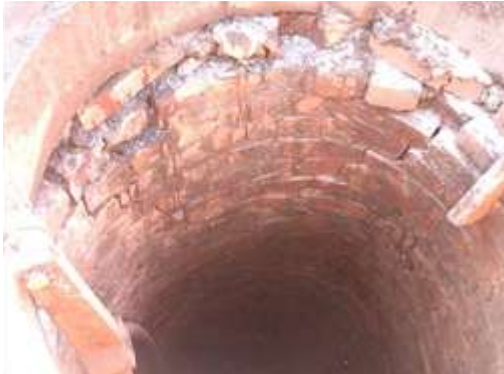
Defect

Frame leaks. Adjustment deterioration, loose brick and infiltration. Corbel cracks and infiltration. Barrel infiltration.

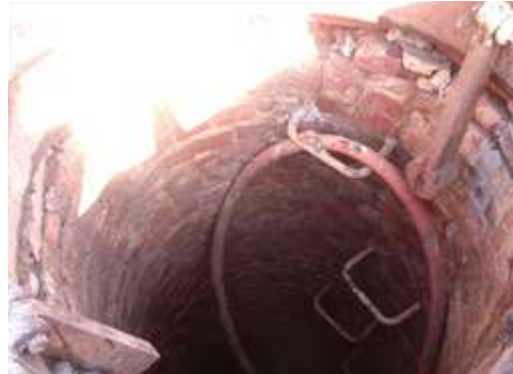
Defect

Frame leaks. Adjustment deterioration, loose brick and infiltration. Corbel and Barrel infiltration.

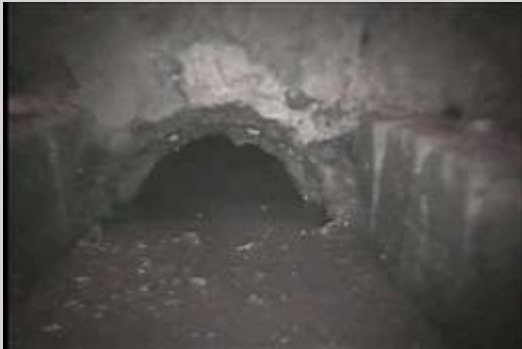
8 in. Circular Gravity Sewer Pipe Out @ 12 O'Clock

Deposits: ☐ None ☒ **Mud** ☐ Sludge ☒ **Debris** ☐ Grease

Silt Depth: **2** (in.) Deposits Extent: **Medium**

Infiltration: **Evidence** Pipe Seal Cond: **Unknown**

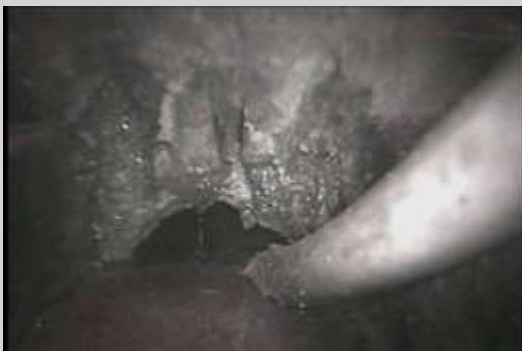
8 in. Circular Gravity Sewer Pipe In @ 6 O'Clock

Deposits: ☐ None ☒ **Mud** ☐ Sludge ☒ **Debris** ☐ Grease

Silt Depth: **3** (in.) Deposits Extent: **Medium**
